**Title:**

Condition assessment of penstock supporting structures of Nagarjuna sagar main powerhouse

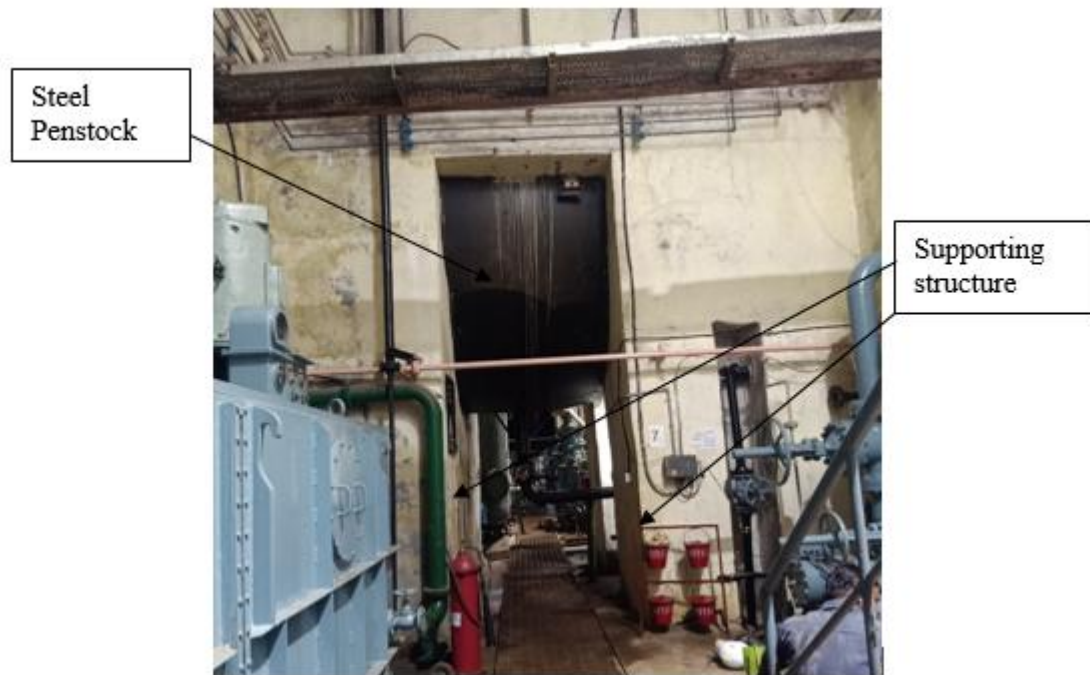
- Detailed visual inspection at accessible locations reveal that (i) dampness/seepage of water, (ii) poor quality of concrete, (iii) aging of the structures, (iv) pump mode operation, (v) inadequate cover to the rebars, (vi) poor maintenance, etc. could be the causes for the deterioration of Penstock support structures. In supporting structures, cracking is dominant in construction joints/cold joints.

Typical photograph of Steel Penstock and its supporting structures/pedestals

- Tests such as UPV, RH, and other electrochemical tests were conducted.
- Wherever, UPV value is less than 3.0km/sec (in the case of direct scanning) or 2km/sec (in the case of indirect scanning) for three or more consecutive grid locations, cement grouting and followed by epoxy grouting is suggested to improve the quality and integrity of concrete.

- Carbonation depth is more in selected locations of Unit 4, Unit 5 and Unit 8, which could be the reason for corrosion initiation of rebars.
- Based on core sampling and testing, the strength of concrete is not satisfying for M20 grade of concrete in Units 5 and 8. Grouting was suggested at these areas for improving the quality and integrity of concrete.
