## Integrity assessment of the prestressed Trunnion beams of the spillway structure of Polavaram dam project through Acoustic Emission (AE) and advanced non-destructive evaluation (NDE) Techniques.

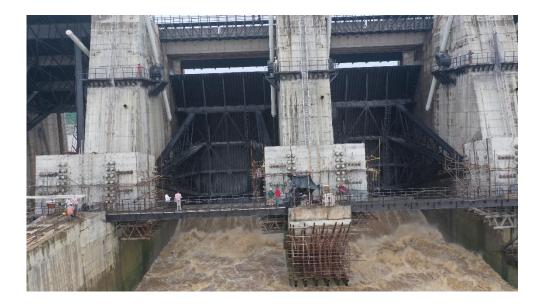
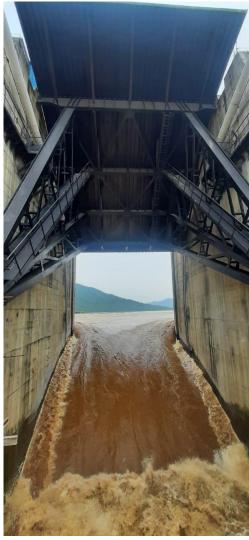
Figure: Integrity assessment of prestressed trunnion beams in Polavaram Dam using Acoustic Emission (AE) technique by CSIR-SERC team
